The Impact of Nepal's 2015 Gorkha Earthquake-Induced Geohazards

Arun Bhakta Shrestha, ICIMOD
Samjwal Ratna Bajracharya, ICIMOD
Jeffrey S. Kargel, University of Arizona
Narendra Raj Khanal, ICIMOD

International Centre for Integrated Mountain Development, Kathmandu, Nepal, May 2016

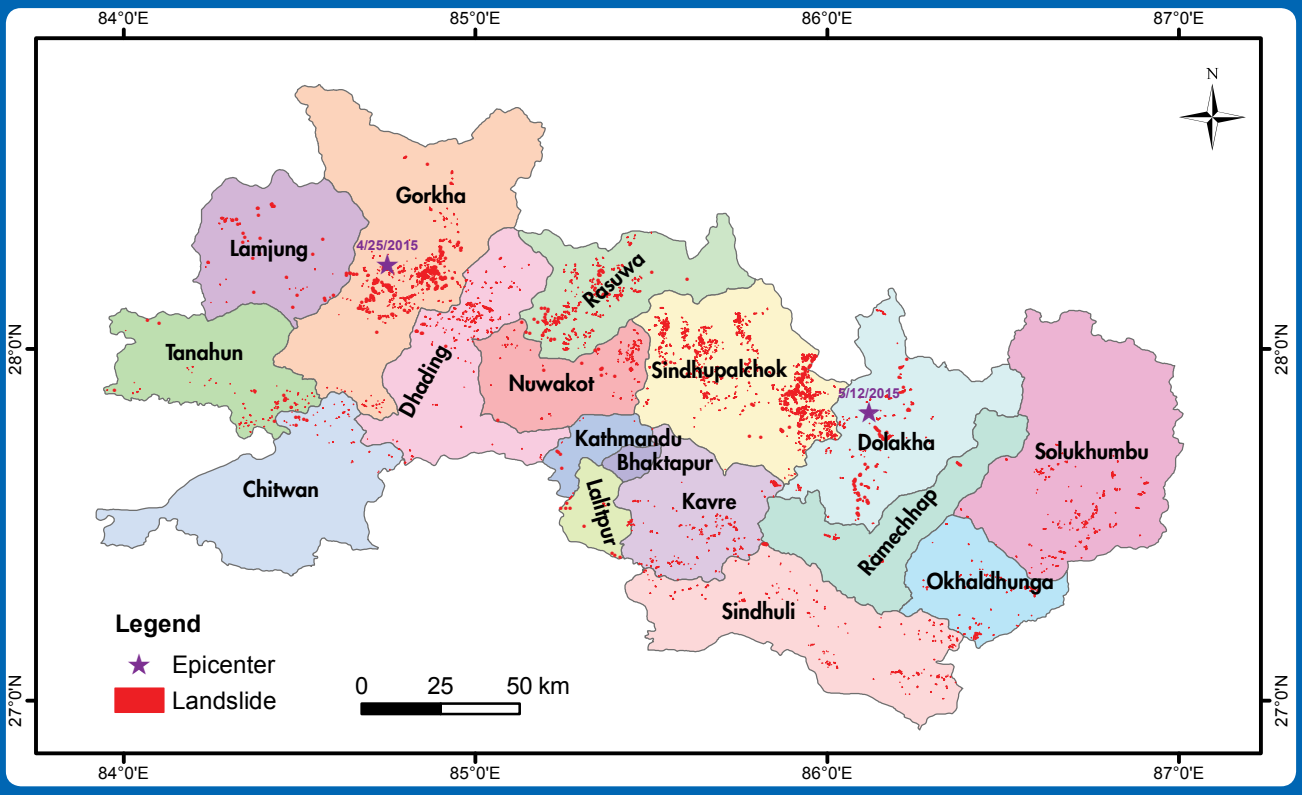
Figure 4: **Landslide inventory of the study districts**

The landslides identified by the international volunteer group were in the form of point maps. To generate polygon maps for impact assessment they were further digitized from Google and DigitalGlobe images and verified through fieldwork. The distribution of the digitized landslides is shown in Figure 4. A total of 5,159 landslides were mapped within the 17 districts (including landslides that existed prior to the earthquake). Earthquake-induced landslides were widespread in the earthquake-affected districts with a greater number in Dhading, Gorkha, Rasuwa, and Sindhupalchok (Figure 5). High resolution satellite data indicated that some landslides in Gorkha district were associated with avalanches.

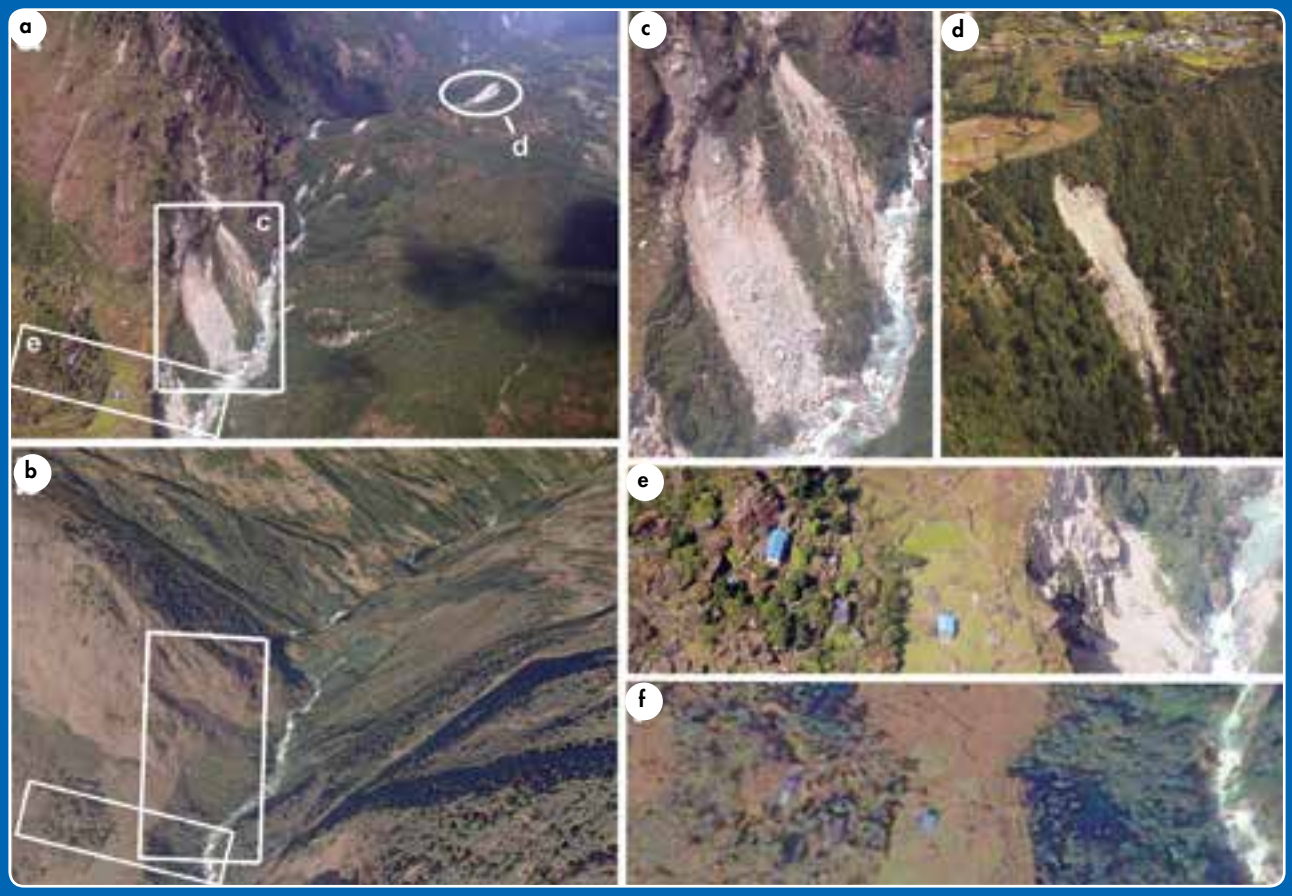
Figure 6: **Earthquake-triggered landslides in the Dudh Koshi valley near Lukla (west side of the river; location 27.666° N; 86.700° E)**

a) Oblique helicopter-borne photo acquired 27 Oct 2015. The scene width through the scene centre is about 700 m. The longest landslide is around 350 m long. b) The landslides did not exist twenty weeks prior to the earthquake, as seen in a Google Earth (CNES/Astrium) rendering of similar perspective from 6 Dec 2014. c) The three landslides that reached river level were all earthquake-related; one originated from terrace deposits, and the other two from the nose of a bedrock ridge crest composed of paragneiss. Another landslide can be seen in the distance (upper right). Peak ground acceleration (modelled) in this area was about 0.08 g, corresponding to weak shaking. (c) Enlargements from (a) showing the thin-skinned nature of these landslides. (d) A different helicopter-borne image shows an earthquake-induced landslide at the edge of Lukla (on the river's east bank) also visible in (a); this landslide also sources from terrace deposits – ancient deposits of a massive landslide which apparently blocked the river for a long time (Götz et al. 2015). (e) Enlargement of (a) shows the head scarp of one landslide, which receded by no more than a couple of metres relative to the pre-quake scene as shown in (f). This image pair also shows that the terrace source of the landslide is a boulder filled rockb fall similar to that documented by Götz et al. on the other side of Dudh Koshi. Other notable features in this area are deep, weathered bedrock fractures (arrows in panels a and b), which existed before the earthquake and fortunately were not discernibly reactivated. Such fractures indicate that a potential existed for much larger landslides than actually occurred.

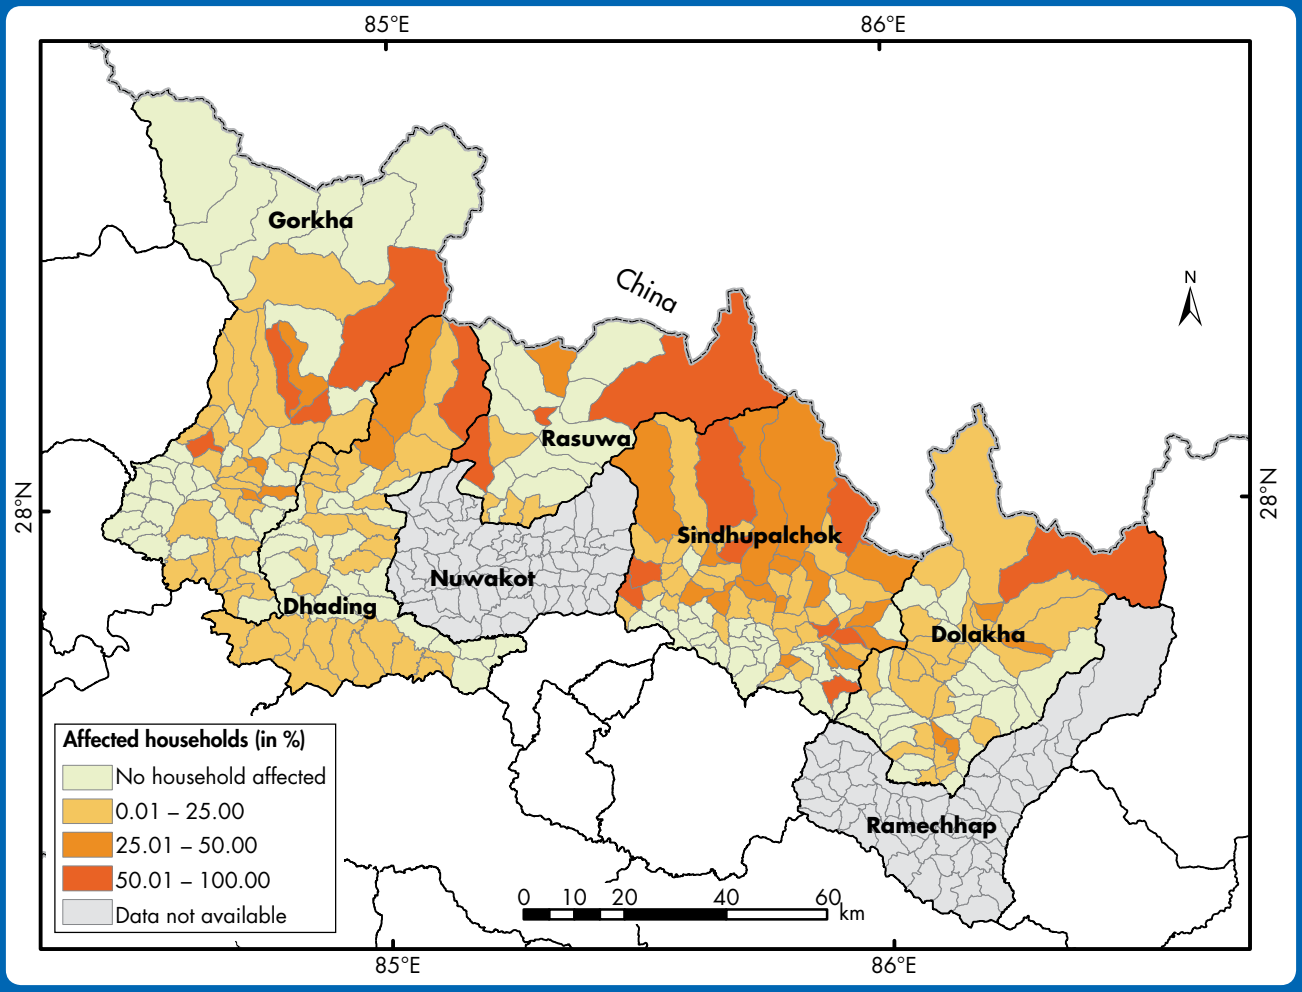
Figure 8: **Percentage of households within individual VDCs affected by earthquake-induced landslides and debris flows**

The nature of geohazards means that they are unevenly distributed. The proportion of VDCs affected within the different districts ranged from 51 to 72% with an average of 59%; and the percentage of households affected within individual affected VDCs ranged from less than 10% to more than 75% (Table 3, Figure 8).

VDCs with more than 50% of households affected:
Dhading: Tipling
Dolakha: Gaurishankar
Gorkha: Kashigaon, Keraunja, Laprak, Lapu
Rasuwa: Langtang, Goljung, Dandagaon
Sindhupalchok: Bhotang, Dhuskun, Ramche, Tatopani, Attarpur, Gunsa, Mahankal, Thakani

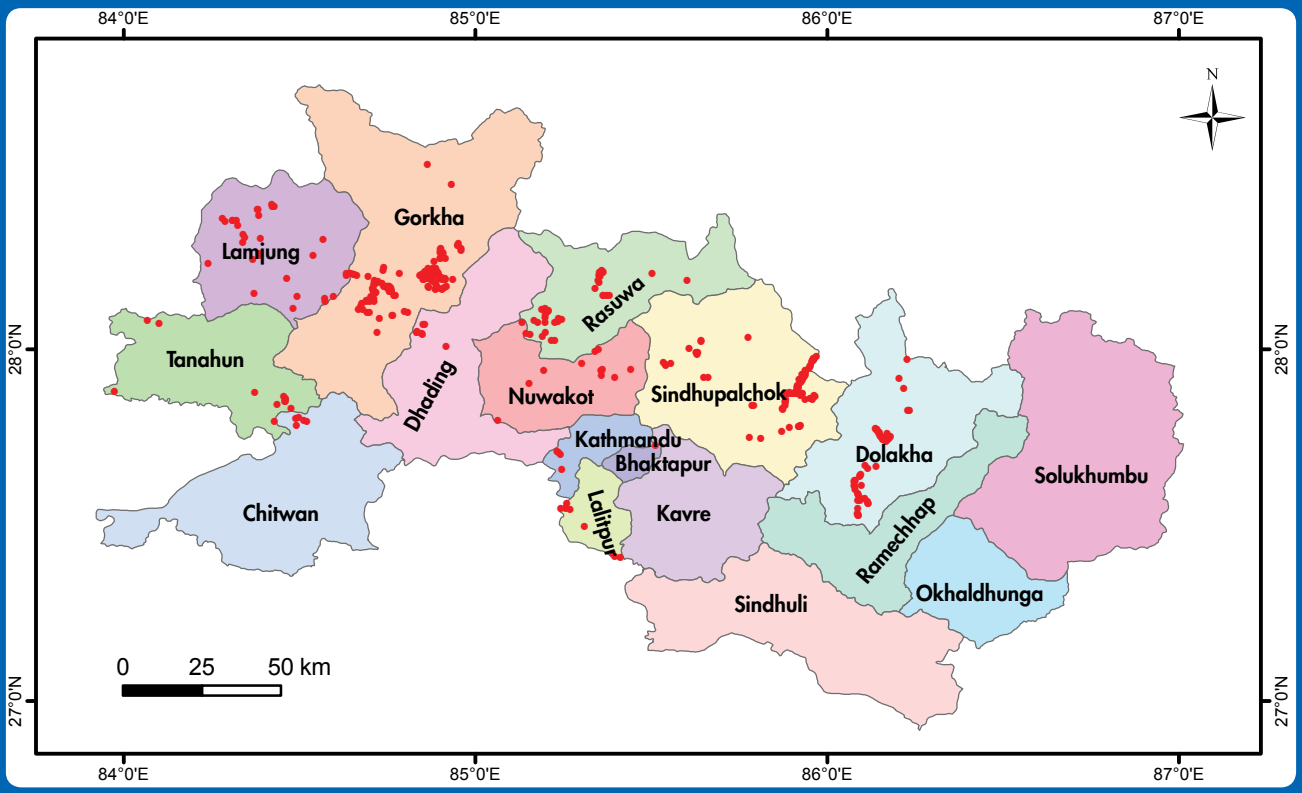
Figure 9: **Earthquake-induced landslides that affected infrastructure in the study districts**

Mapping of earthquake-induced landslide impacts was carried out for all the districts classed as severely hit, crisis hit, or hit by heavy losses by GON (Figure 2) (with the exception of Khotang and Makwanpur where there were no landslides). Of the total 5,159 landslides mapped in the 17 districts, 464 landslides in 11 districts affected roads, hydropower projects, bridges, irrigation systems, and/or buildings (houses, schools, and others) (Figure 9). The number of these landslides in each of the 11 affected districts is shown in Table 7; there were no landslides affecting infrastructure in the remaining six districts. Details of the affected infrastructure are provided in the following sections.

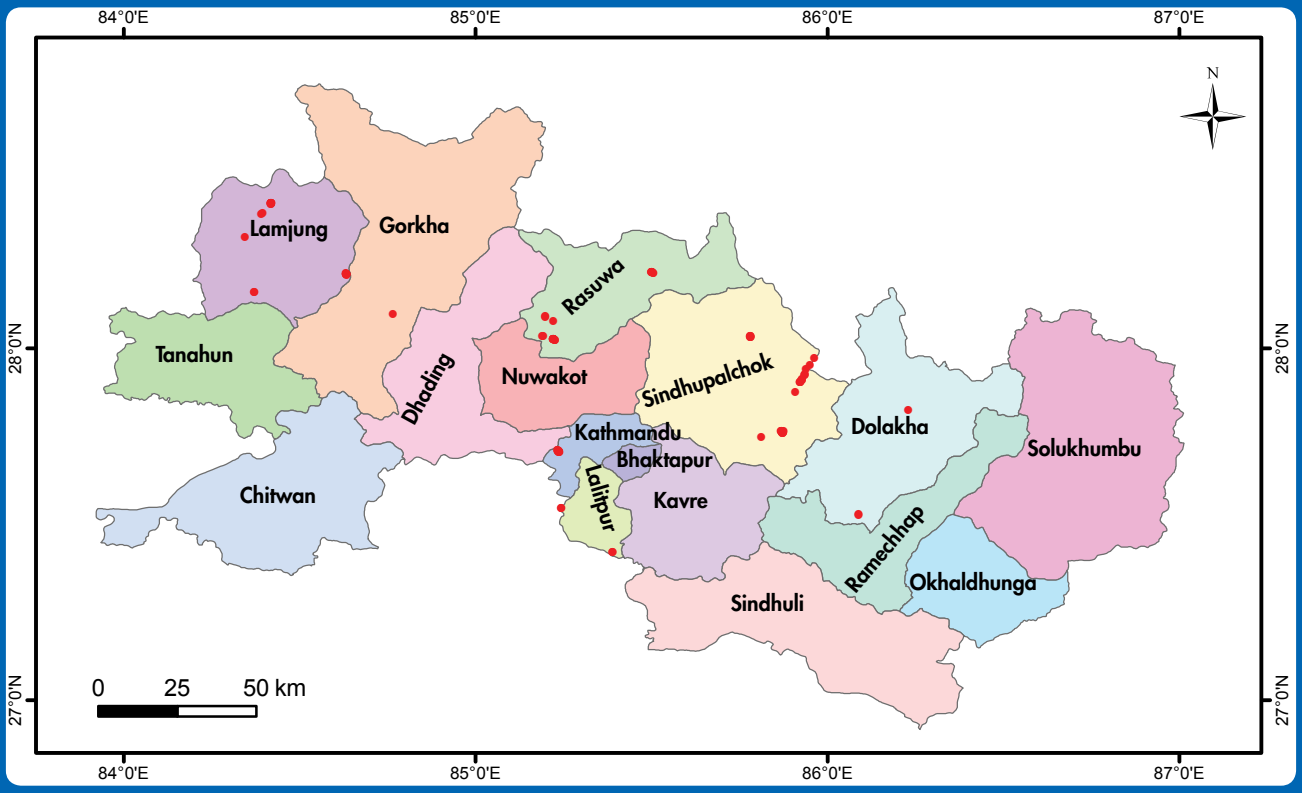
Figure 10: **Buildings damaged or destroyed by earthquake-induced landslides in the districts studied**

A huge number of low strength masonry buildings were damaged by the earthquake. Of these, the number damaged by earthquake-induced landslides was relatively small, although still significant. The inventory of damaged buildings was digitized and the positions overlaid with the area of earthquake-induced landslides. A total of 109 buildings fell within landslide areas (Figure 10; Table 8). Not all damaged buildings were identified at the time of the inventory thus the actual number could be slightly higher

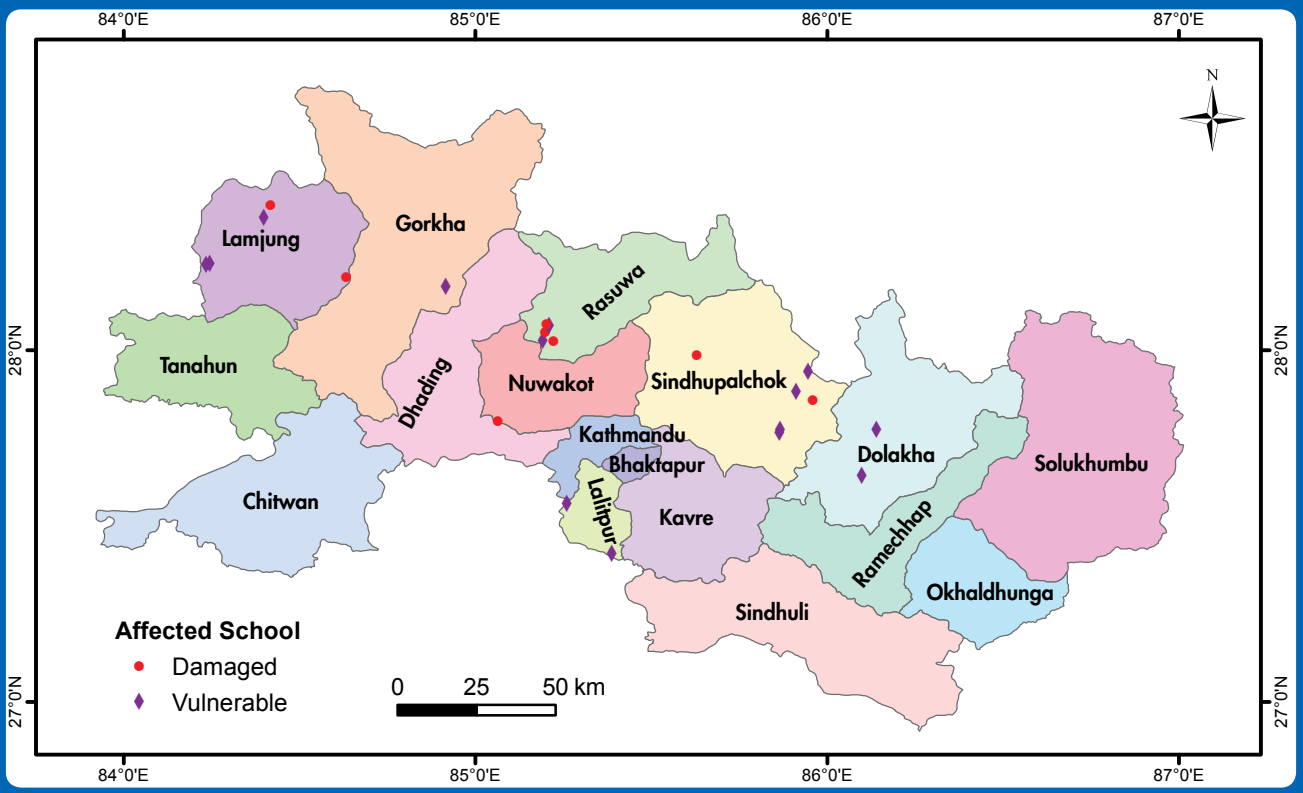
Figure 12: **Schools affected by earthquake-induced landslides in the districts studied**

Many school buildings in the study districts were severely damaged but only a few were damaged by landslides. The mapping identified a total of 22 school buildings damaged by earthquake-induced landslides (Figure 12; Table 9); eight directly hit and 12 schools made vulnerable.

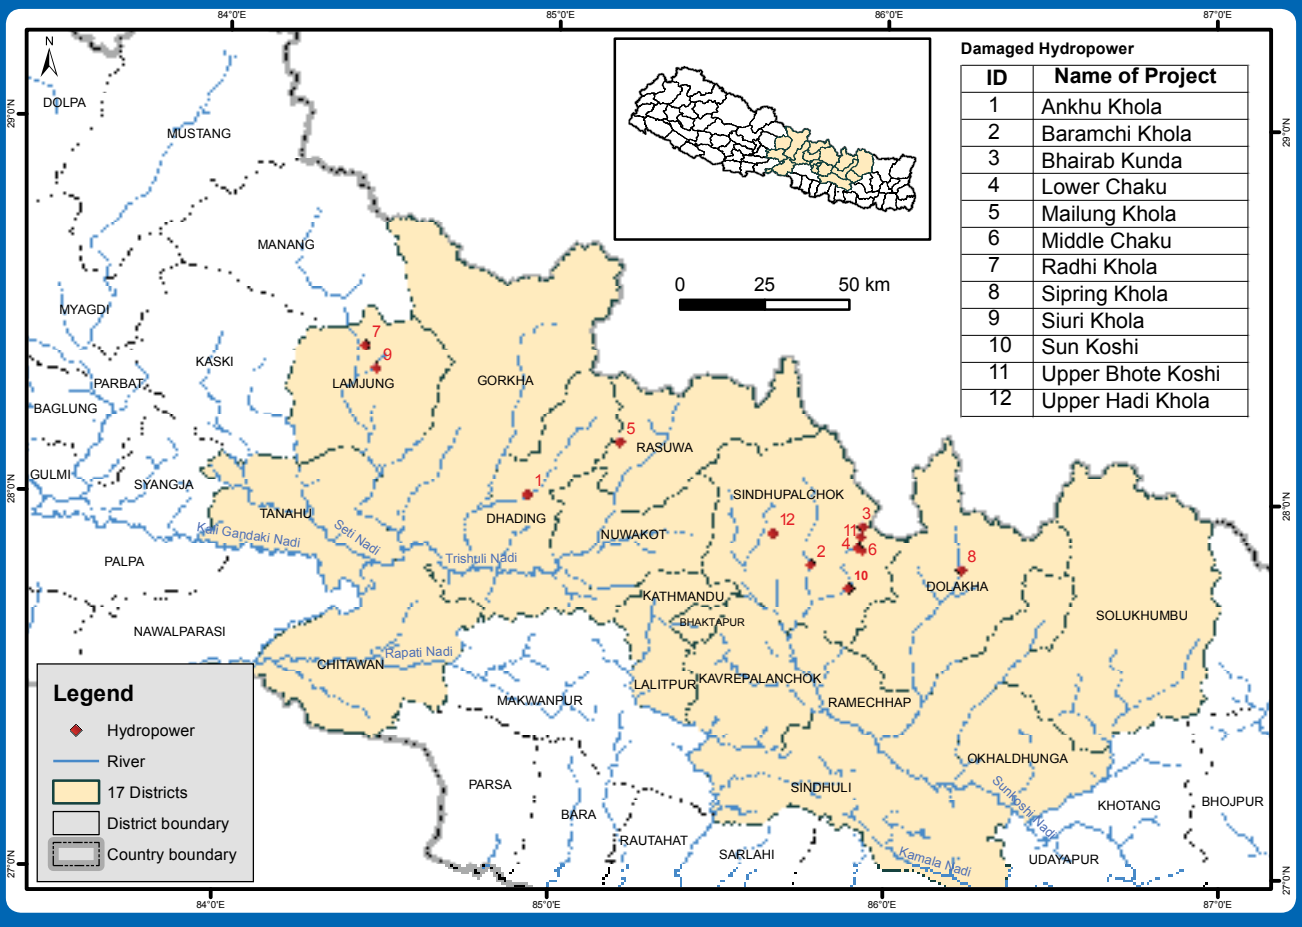
Much of the damage resulted from the direct impact of shaking, but a number of installations were damaged by rock falls and landslides. The location of the hydropower projects affected by earthquake-induced landslides is shown in Figure 13 and the damage suffered is summarized in Table 10. Landslides and rock falls also affected a number of projects under construction. The Upper Tamakoshi Hydroelectric Project in Sindhupalchok, the largest hydroelectric project under construction (456 MW, run-of-the-river) has experienced considerable delays in completion due to damage caused by the landslides, mainly to the access road. The 111 MW Rasuwagadhi hydropower station sustained serious damage due to a landslide and debris flow, and the 24 MW Upper Trishuli 3A project was hit by landslides and much of the access road to the dam was washed away.

Figure 13: **Location of hydropower projects affected by earthquake-induced landslides and rock fall**

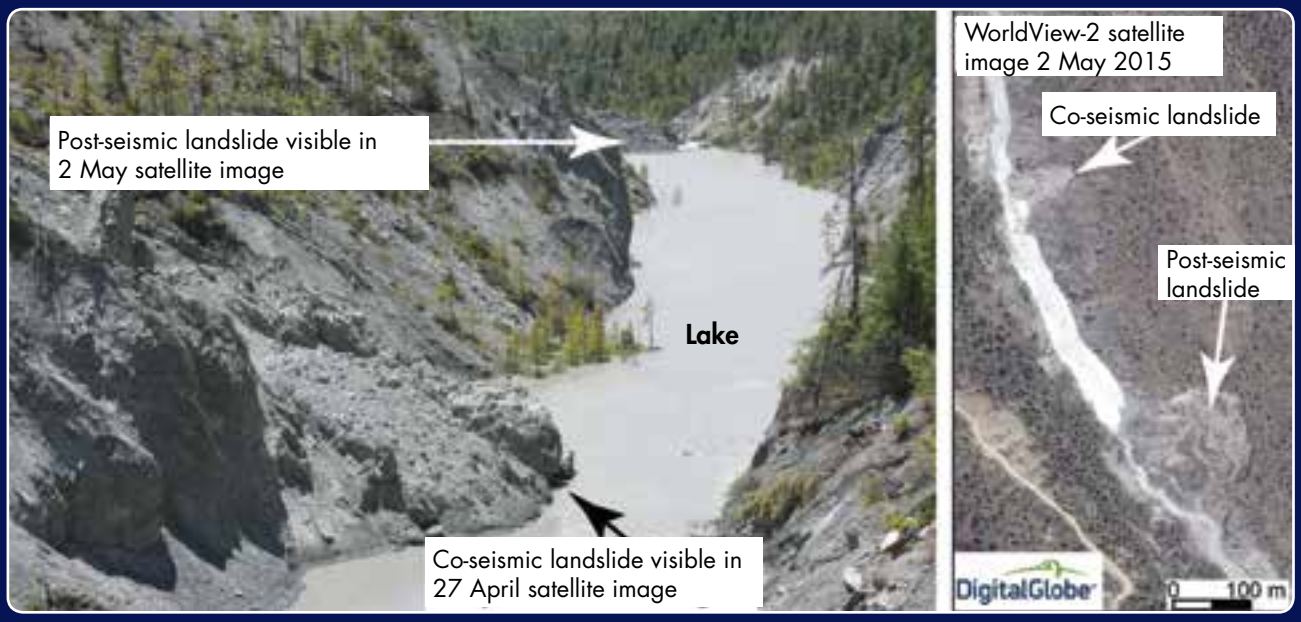
A further landslide blocked the Marsyangdi River close to Bhratang village in Manang at 28.567°N, 84.183°E (Figure 18). The blockage was identified in an image from 27 April which showed 10 houses on the left bank at the

Figure 17: **Marsyangdi River near Bhratang (left picture courtesy Mukhiya Gotame, Manang villager; right, WorldView-2 satellite image 2 May 2015)**

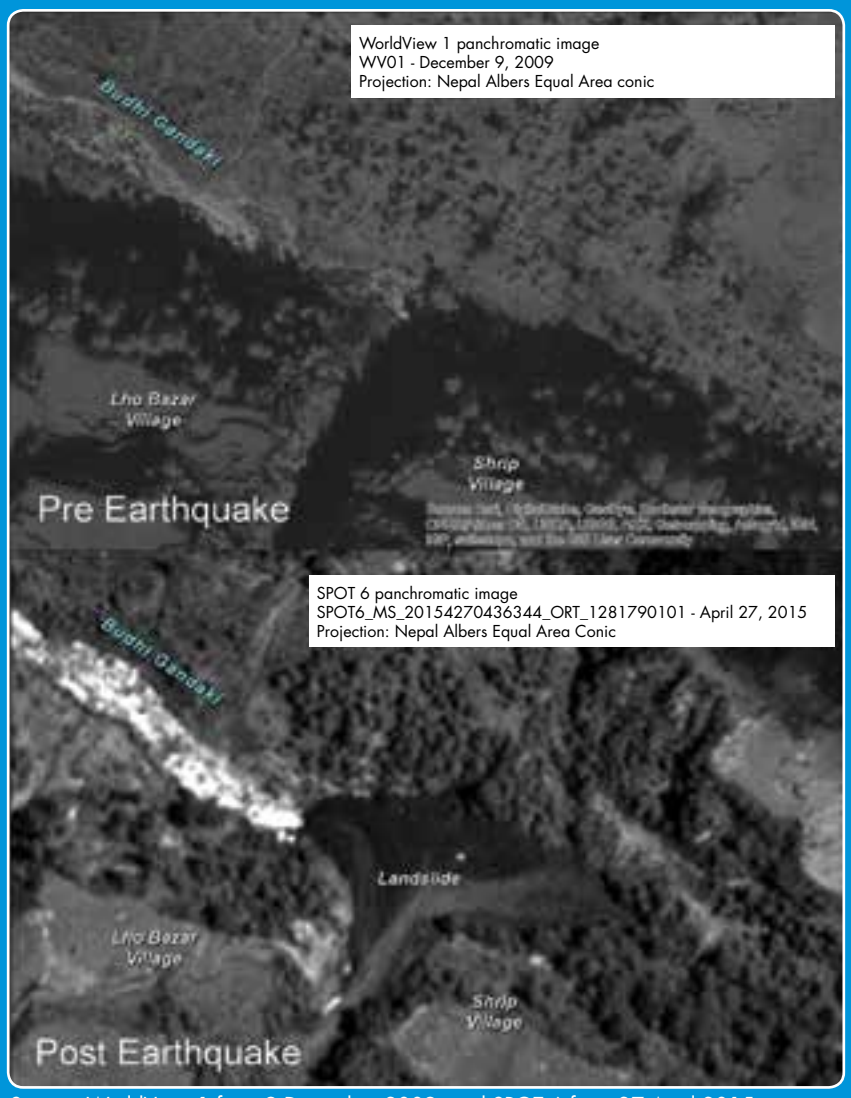
Figure 21: **Landslide from Lanjam glacier terminal moraines blocking the Budhi Gandaki River in Manaslu**

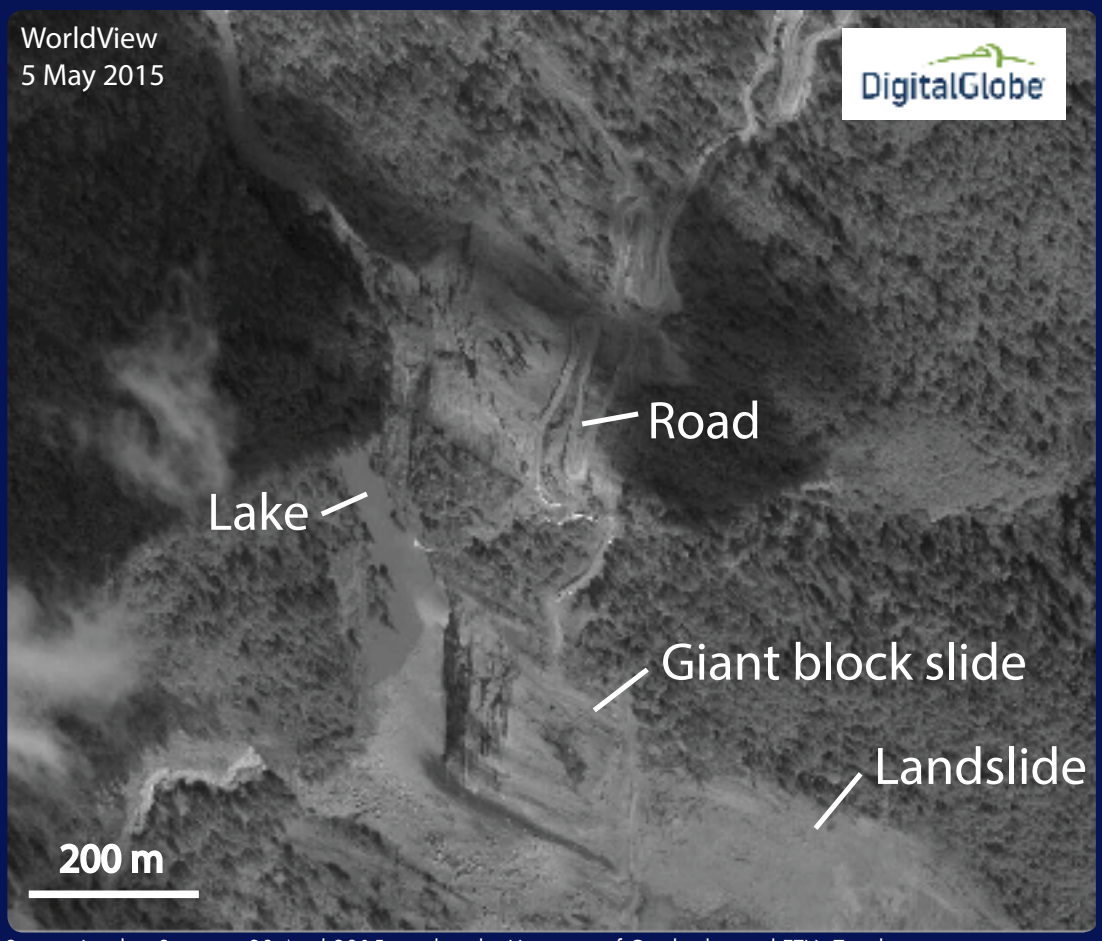
Figure 23: **Large landslide blocking the road and damming the Trishuli River at Chongsecun 7 km north of the China/Nepal border**

A large landslide (800 x 200 m) crossed a road and dammed the Trishuli River (also known as the Gyriong Zangbo) at Chongsecun 7km north of the China/Nepal border (~2,600 masl) at 28.359°N, 85.365°E (Figure 23). A lake approximately 100 m wide and 500 m long had formed by 30 April 2015. The lake was considered to pose a high risk if the dam breached, with a potential for downstream flooding, but then drained naturally without causing damage.

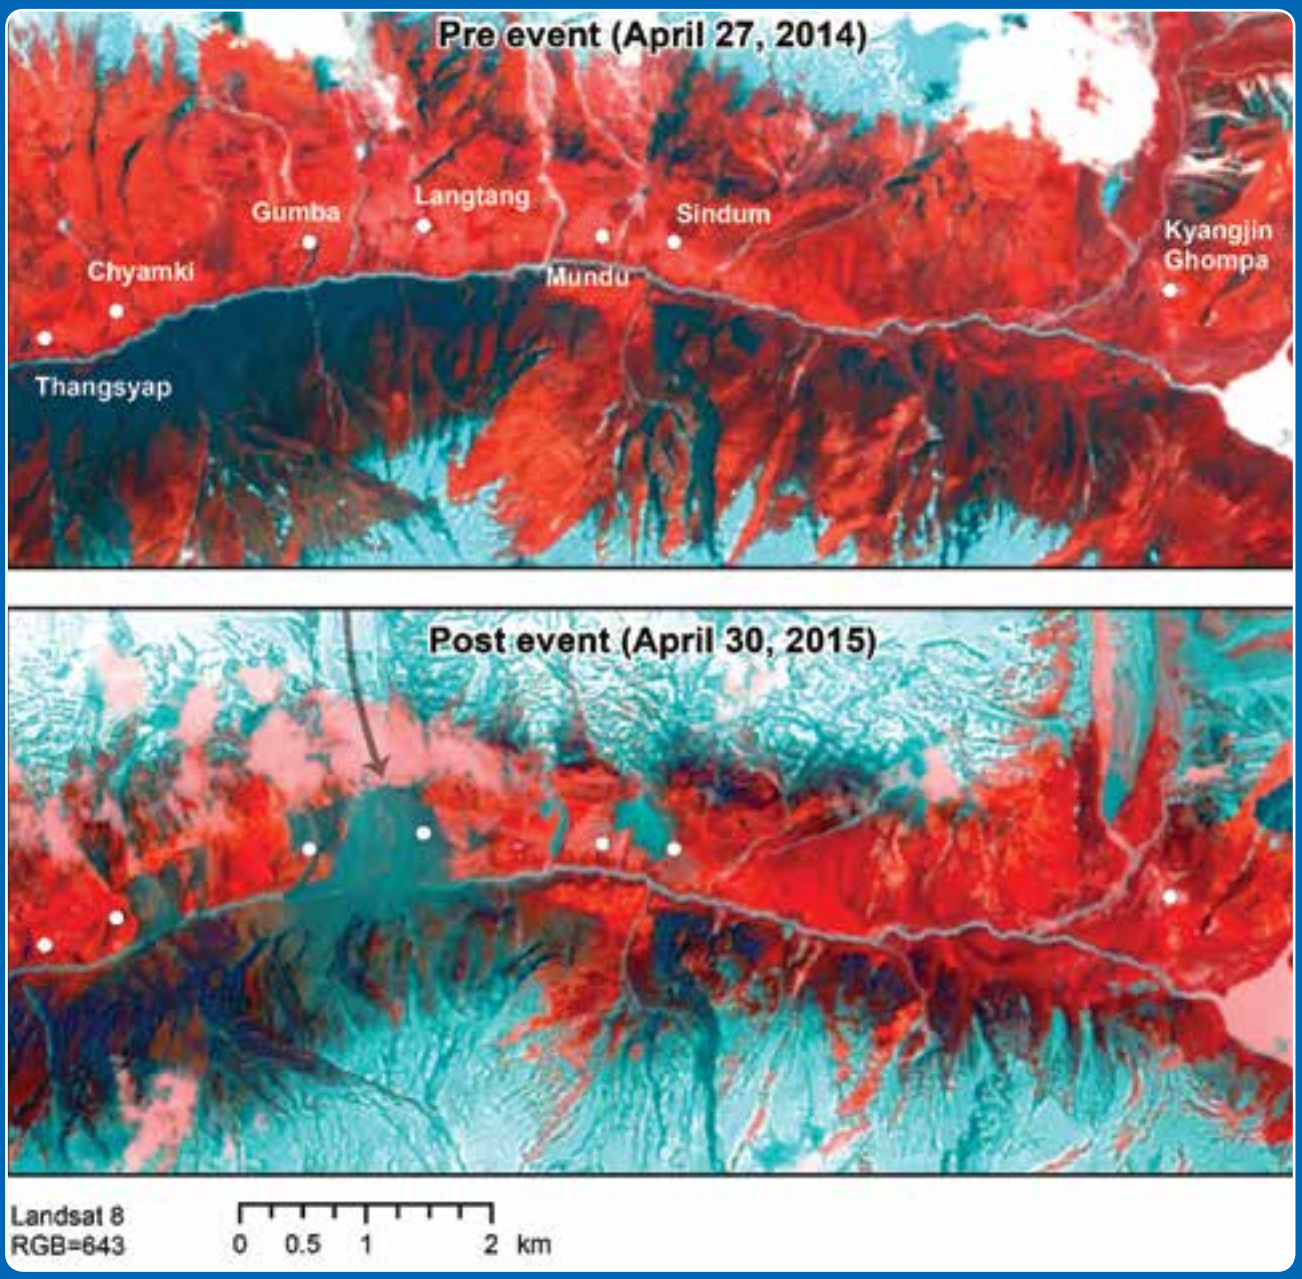
The most destructive and probably the largest landslide triggered by the 2015 earthquake was a massive landslide/avalanche initiated near 7,000 masl which completely buried Langtang village and deposited materials (ice, rock and soil) across the Langtang River. Kargel et al. (2016) estimated that the ice-snow avalanche initiated near 7,000 m elevation with entrained rockfall material and descended along a low-gradient part of the glacier to ~4,500 masl, from where the rock-ice mass became airborne down to the riverbed at ~3,250 masl. A study by Lacroix (2016) based on analysis of digital elevation models estimated the deposit at 7 million cubic metres, more

Figure 26: **Langtang village is completely buried under the landslide debris**

than half of which could have been ice. The pre- and post-earthquake images show Langtang and Gumba villages completely buried under the debris (Figure 26). The river apparently melted the ice deposited in the river channel and the water flowed through a tunnel which formed in the ice and debris. The 25 April avalanche/landslide was followed by another similar size landslide around 8 to 10 May. There were more than 300 estimated fatalities. There was no evidence of lake formation upstream of the landslide.

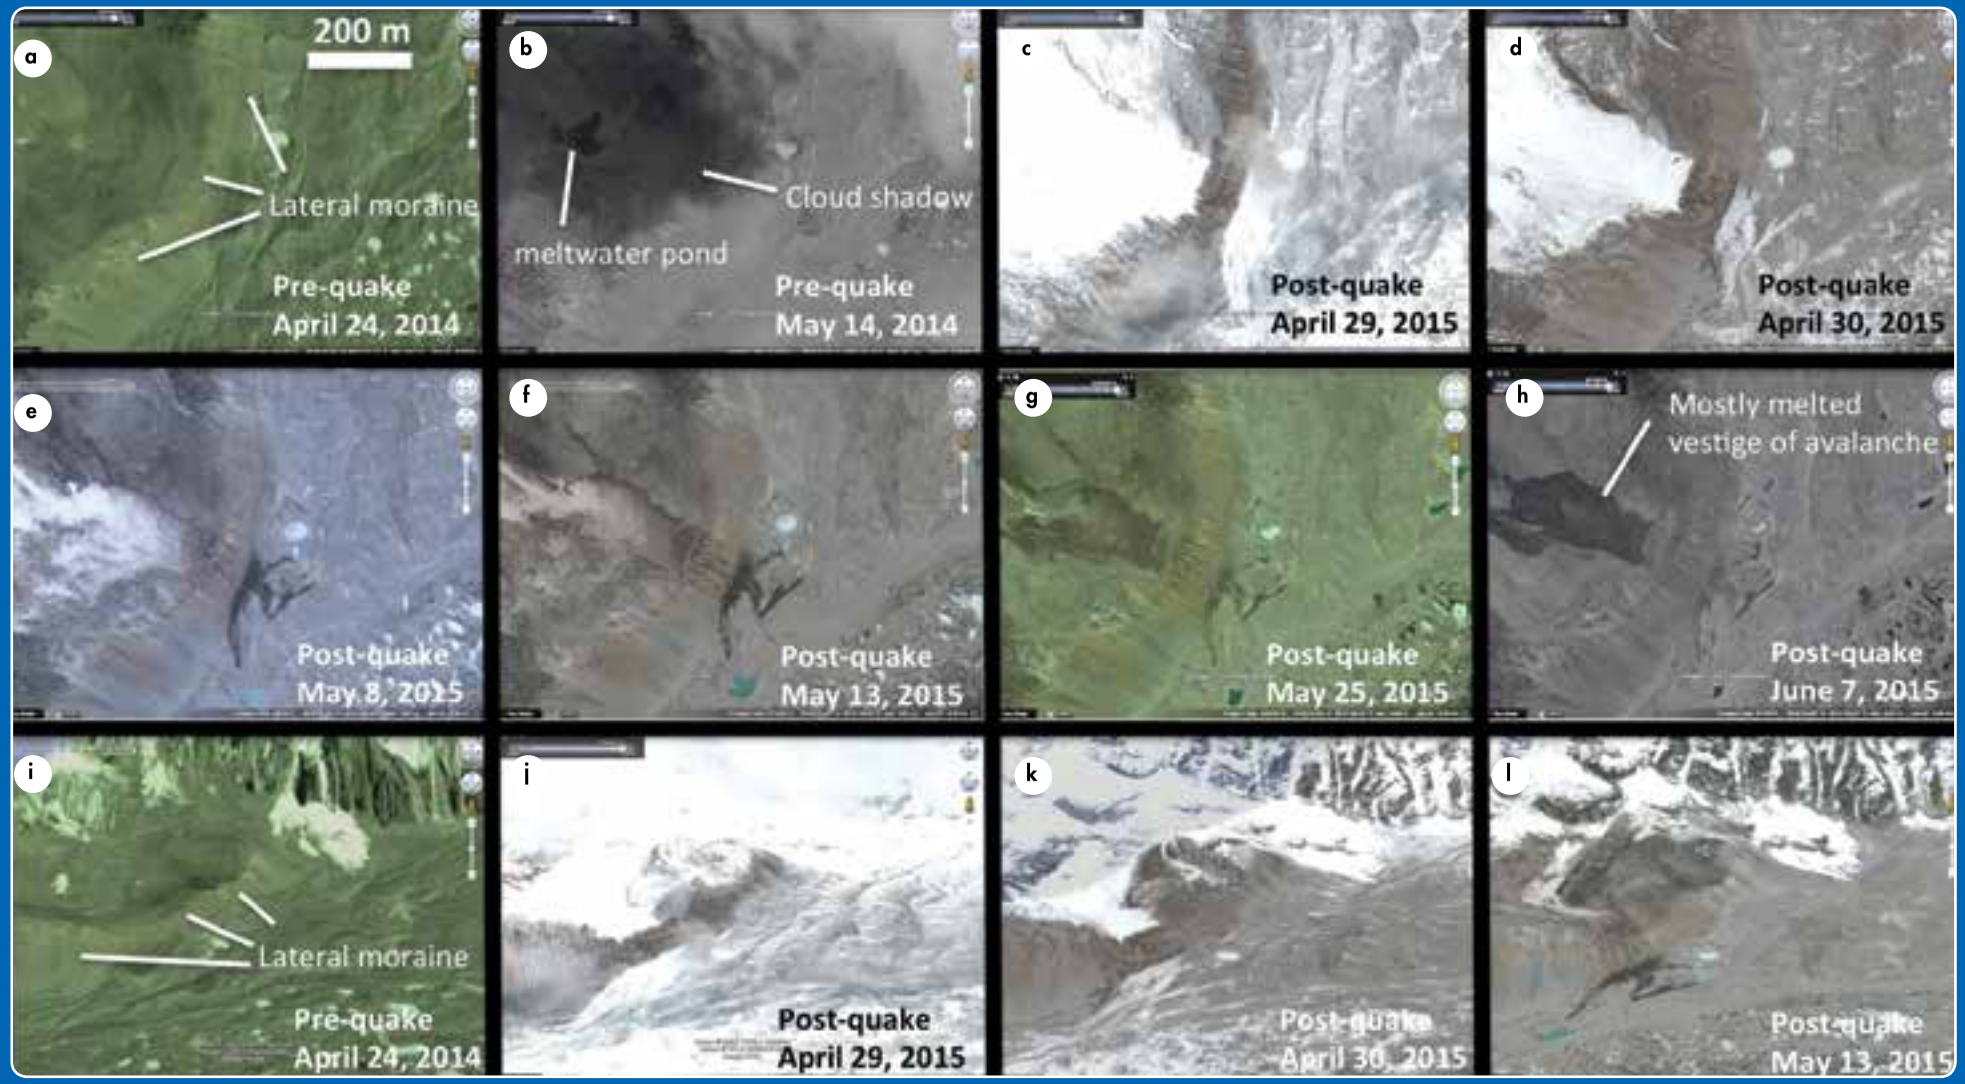
Everest Base Camp was also hit by an earthquake-induced ice avalanche, even though shaking at this point was light. The tremor on 25 April 2015 unleashed what was probably a hanging glacier (Figure 27). The collapsing icy mass swept away a part of Everest Base Camp, and with it 22 lives. It was the worst single day in the history

Figure 27: **Earthquake triggered ice and snow avalanche onto the Khumbu glacier near Everest Base Camp; images from DigitalGlobe and CNES/Astrium rendered in Google Earth. Top panels show an ortho view zoomed in to the tongue of one avalanche where it spilled over the lateral moraine and onto the Khumbu glacier; A and B are pre-quake images taken about a year before the earthquake. C through H are post-quake images obtained in 2015 showing the rapid melting of the avalanche. The bottom panel is an oblique rendering of this and other avalanches with prequake and post-quake images. 28.012°N, 86.833°E**

The indication is that ice was poised on the mountain ready to collapse. Springtime melting triggered the collapse in 2014 and probably conditioned the ice for collapse in 2015 so that only a light shaking was needed to break it loose (calculated peak ground acceleration only 0.08 g).

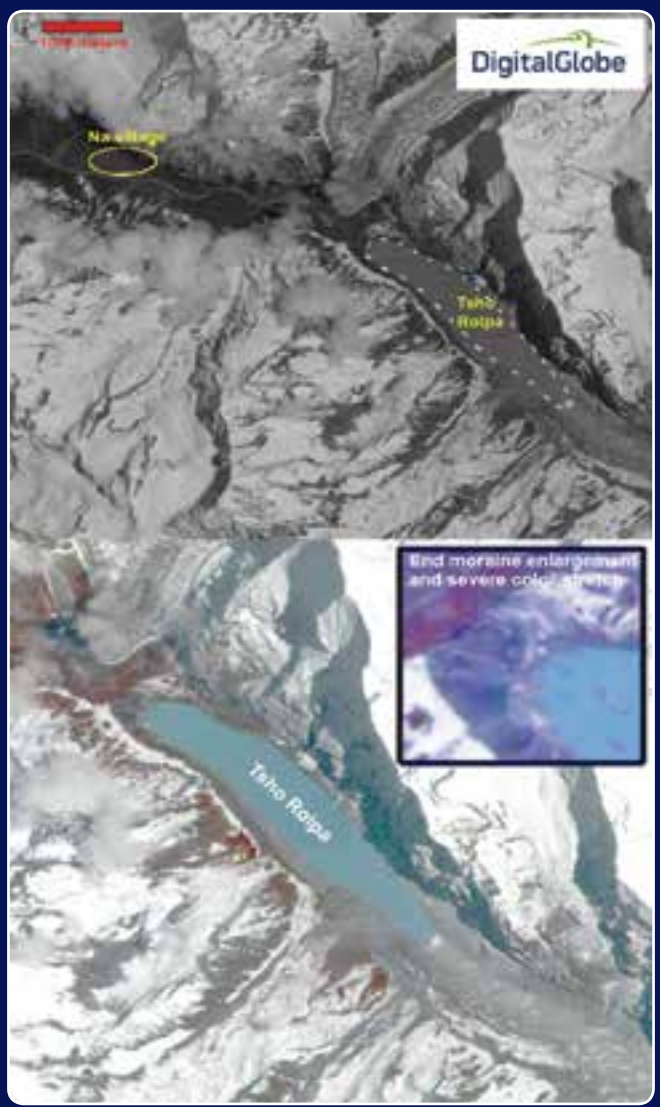
Figure 28: **Satellite images of Tsho Rolpa lake:**

a) DigitalGlobe image from January 2015; b) EO-I ALI image from 17 May 2015

the moraine dam or the engineered structures used to lower and control the lake level. Both the satellite images and these aerial photos show that the lake was still well-contained within the moraine dam. This was further corroborated by a photo taken on 27 May 2015 during a helicopter mission organized by USGS, which showed the moraine to be intact as far as could be seen. Additional aerial and ground-based photos were obtained by an independent citizen, Saroj Dhoj Joshi, and made available for the research (http://web.hwr.arizona.edu/GLIMS/2015-TshoRolpaNepal-Photos-SarojDhojJoshi.zip). These photos show the hazardously poised lateral moraine and adjacent mountain slopes, yet they also show no indication of recent disturbances caused by the earthquakes. This work is an example of how satellite imaging, expert knowledge, and 'citizen science' can work together to contribute to discussions of public safety in the aftermath of a natural disaster.

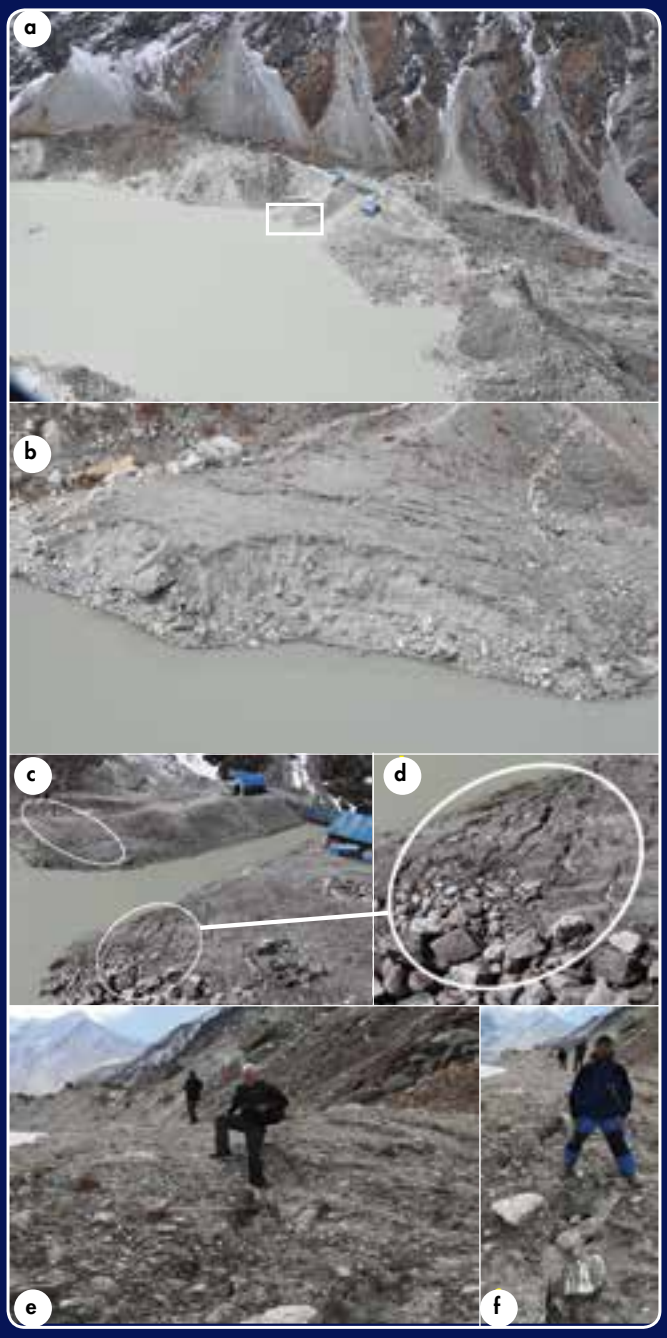
The observations did reveal the formation of cracks in the moraine (Figure 29). USGS scientists Bryan Collins and Randall Jibson observed fractures with a fresh appearance in the end moraine dam in July 2015, and considered that they were probably related to shaking of the engineered surface close to the artificial outlet. They suggested that the cracks were the result of surficial lateral spreading in cohesive sediments and not indicative of larger failure at depth. This could be confirmed in future studies using a geophysical imaging campaign to see if densities or water contents below this section are different to those in the non-cracked areas. During a brief field visit on 28 October 2015, the authors of the present study found that the fractures had degraded during the monsoon months (Figure 29e,f). One point of concern was that the fractures seemed to have some roots in the engineered moraine material, and micro-cavern development had been taking place. However, the field research team considered that the fractures are unlikely to indicate any great damage. Because this part of the moraine does not contain ice, the cracks are unlikely to induce a failure of the moraine dam. Rather, they may imply a relatively mild slumping of some moraine material towards the lake. However, there is still a lack of information about how the deeper structure of the moraine may or may not have been affected by the earthquake. Further investigation of this, and remediation of any problems at an early stage, is necessary.

Figure 29: **Tsho Rolpa lake:**

a) The artificial outlet; b) close view of the right bank of the inlet to the artificial outlet indicated by the rectangle in a); c) cracks on the banks of the inlet (source USGS); d) detailed view of cracks in the right bank of the inlet shown by the ellipse in the bottom part of c; and e, f) detailed view of the cracks indicated by the ellipse in the top part of c)

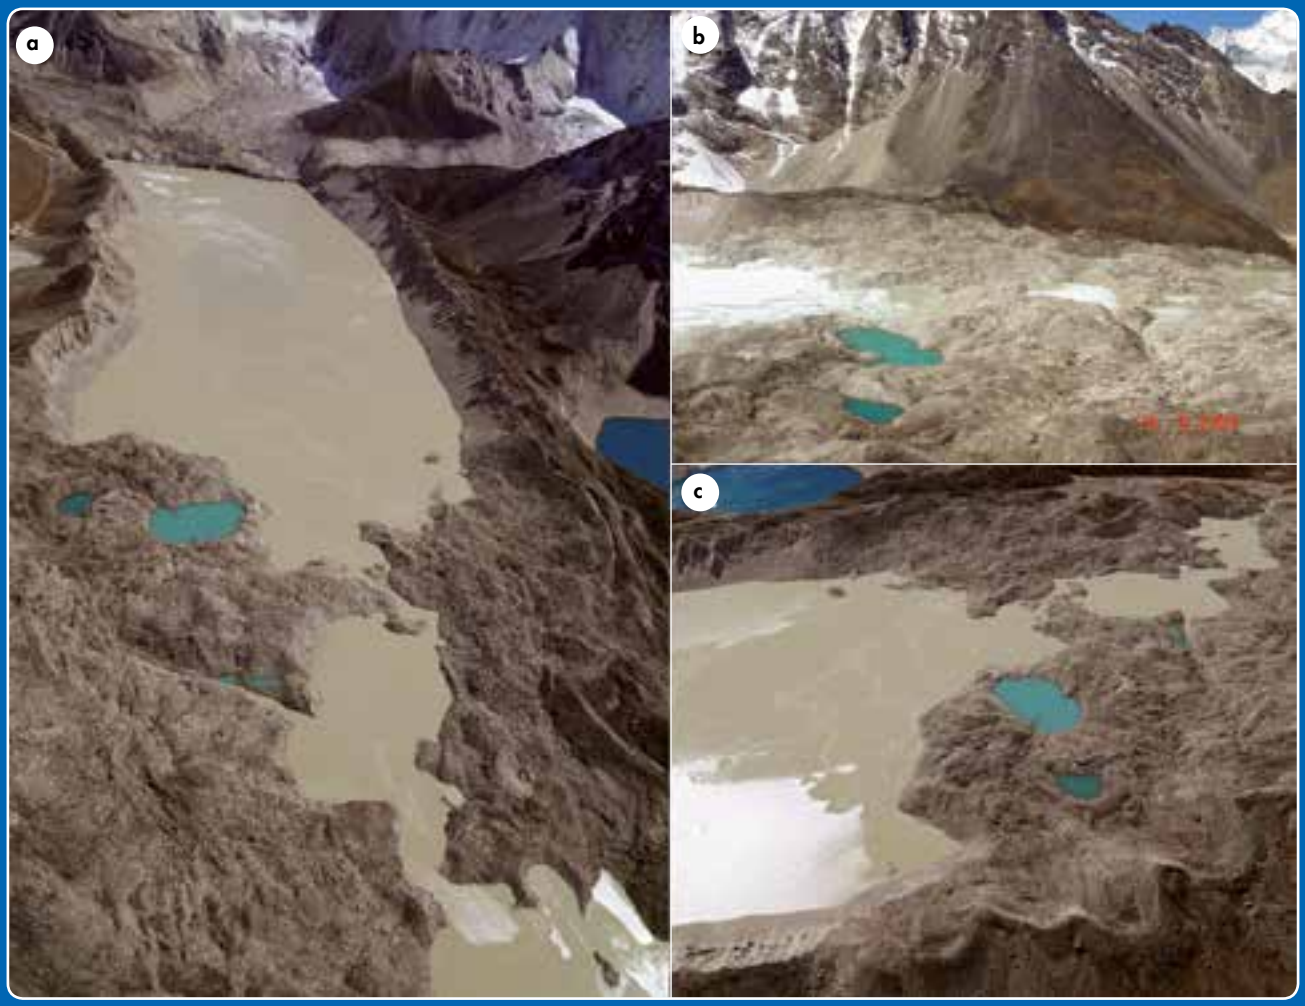
A report was widely circulated on social media that a small GLOF may have occurred on 24 May in the vicinity of Imja lake. Residents reported a loud sound heard several kilometres away – possibly from Lhotse glacier (south of Everest) – which was followed by a transient, anomalous rise in stream level. However, there is no evidence that points towards Imja Lake as the source. Instead, the event is thought to have resulted from ice fracturing and a small supraglacial pond draining from Lhotse glacier. This is the only possible GLOF reported from the region in the weeks following the Gorkha earthquake. It caused alarm but no damage, and may have been related more to spring melting than to the earthquake.

Figure 30: **a) Aerial view of Imja lake; b) end moraine and outlet channel of Imja lake in 2009; and c) similar view in October 2015 after the earthquake**
